INTERNATIONAL WORK

The **WRA Bulletin** is a quarterly publication, and relies on contributions submitted by Partners, Associates and Consultants. The document is circulated by email, and published on the WRA web-site, aiming to keep the WRA network up-to-date with respect to current activities. Please email contributions for future issues to Paul Whitehead: paul.whitehead@watres.com

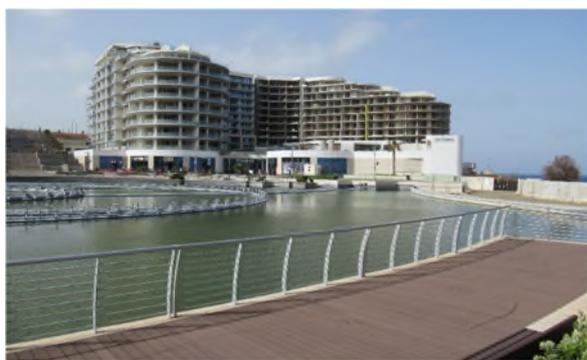
Lagoon and fountains at Kalkara Smart City

WRA undertook a review of the local climate, hydrology and ground conditions using GIS and satellite imagery and climatic records available on line. In addition, reports were provided from the site design including an assessment of the geology and the results of exploratory boreholes. The flooding of the site due to natural conditions was dismissed. Mediterranean climate of Malta with a summer drought meant that zero rainfall was recorded during the time of dewatering. Likewise, available groundwater data recorded the water table in the permeable limestone aquifer to be some depth below the base of the foundations. Instead the presence of an artificial lagoon built around the site with fountains was identified as the cause of the seepage as its completion and filling matched the start of the dewatering from construction records. A later visit to the site with the completed retail centre confirmed the lagoon as an entirely artificial feature.

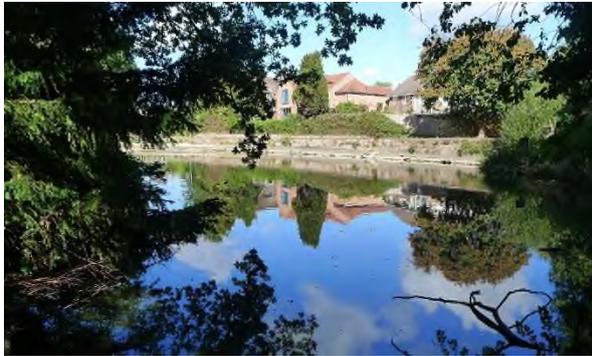
Widmore Pond is likely an old 17th Century sand pit, filled from superficial groundwater with 0.3 m of water and over 0.8 m of soft mud on a hard bottom. Maximum volumes of water and sediment in the pond are 490 m³ and 785 m³. Pond area of 1162 m²

The pond occupies an outcrop “window” of Lambeth Group [LG] clay and sand between Head deposits to the north and Winter Hill Gravel [WHG] south, overlying Chalk. The pond is fed from springs and a deep hollow south of the pond, capturing WHG/LG groundwater. Construction of a retirement village began in 2024, and pond water level declined and never recovered, such that the Parish Council had to pump mains water to prevent drying up.

The retirement village reduces groundwater by diverting all runoff into Chalk borehole soakaways, and by sheet-piling around Widmore Spring.

Groundwater inflow could be increased by construction of a gravity-feed aquifer drain and caisson to capture LG groundwater, or by construction of a Chalk production borehole.

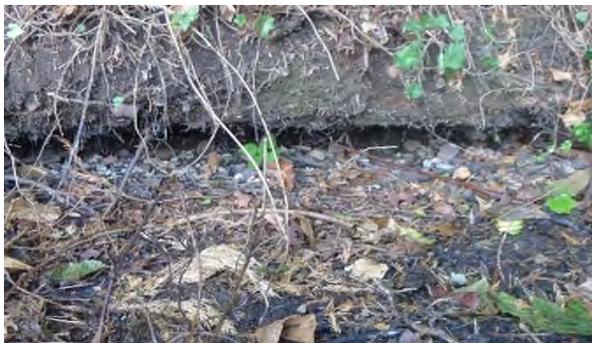
Cavity marking line of groundwater resurgence at south-east end of pond

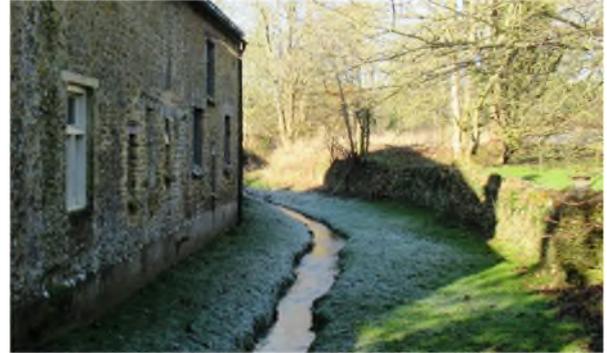
Little Tew Brook under normal conditions

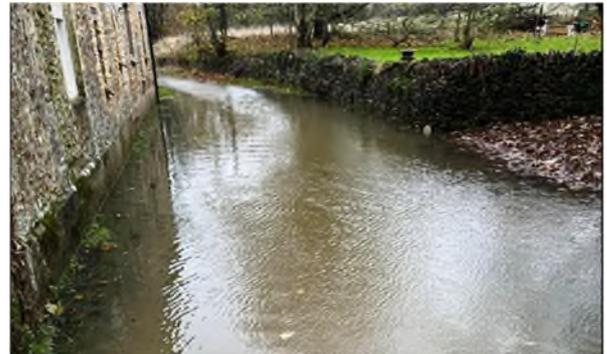
The stream rose and water seeped through the walls of the cottages, which were flooded to a depth of 0.1m.

Little Tew Brook during Storm Bert flooding

ReFH2 software was used to estimate peak flow of 0.5-0.6 m³/s associated with Storm Bert, applying 15-minute rainfall data from the Chipping Norton gauge. Flood water was restricted by a 0.6 m culvert near the property entrance with a capacity of 0.41 m³/s. Alleviation measures proposed an overflow culvert, the diversion of water into a neighbouring paddock and use of a borehole soakaway into underlying permeable Marlstone Rock Formation. Other SuDS measures were proposed to reduce surface water input to the stream.

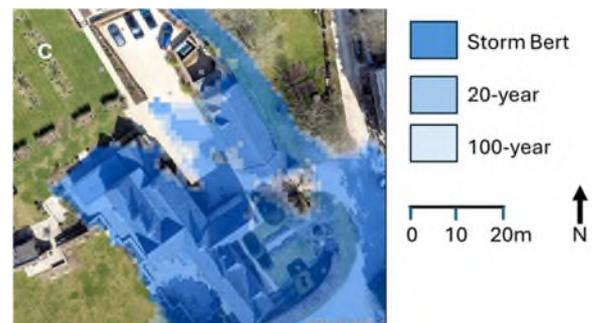
Predicted flood extents for three flood scenarios
